Manual for Dismantling, Documenting and Rebuilding Historic Tiled Stoves

—Sustainable Heritage Report No. 3

A joint project between Gotland University, Estonian Academy of Arts
and Novia University of Applied Sciences.

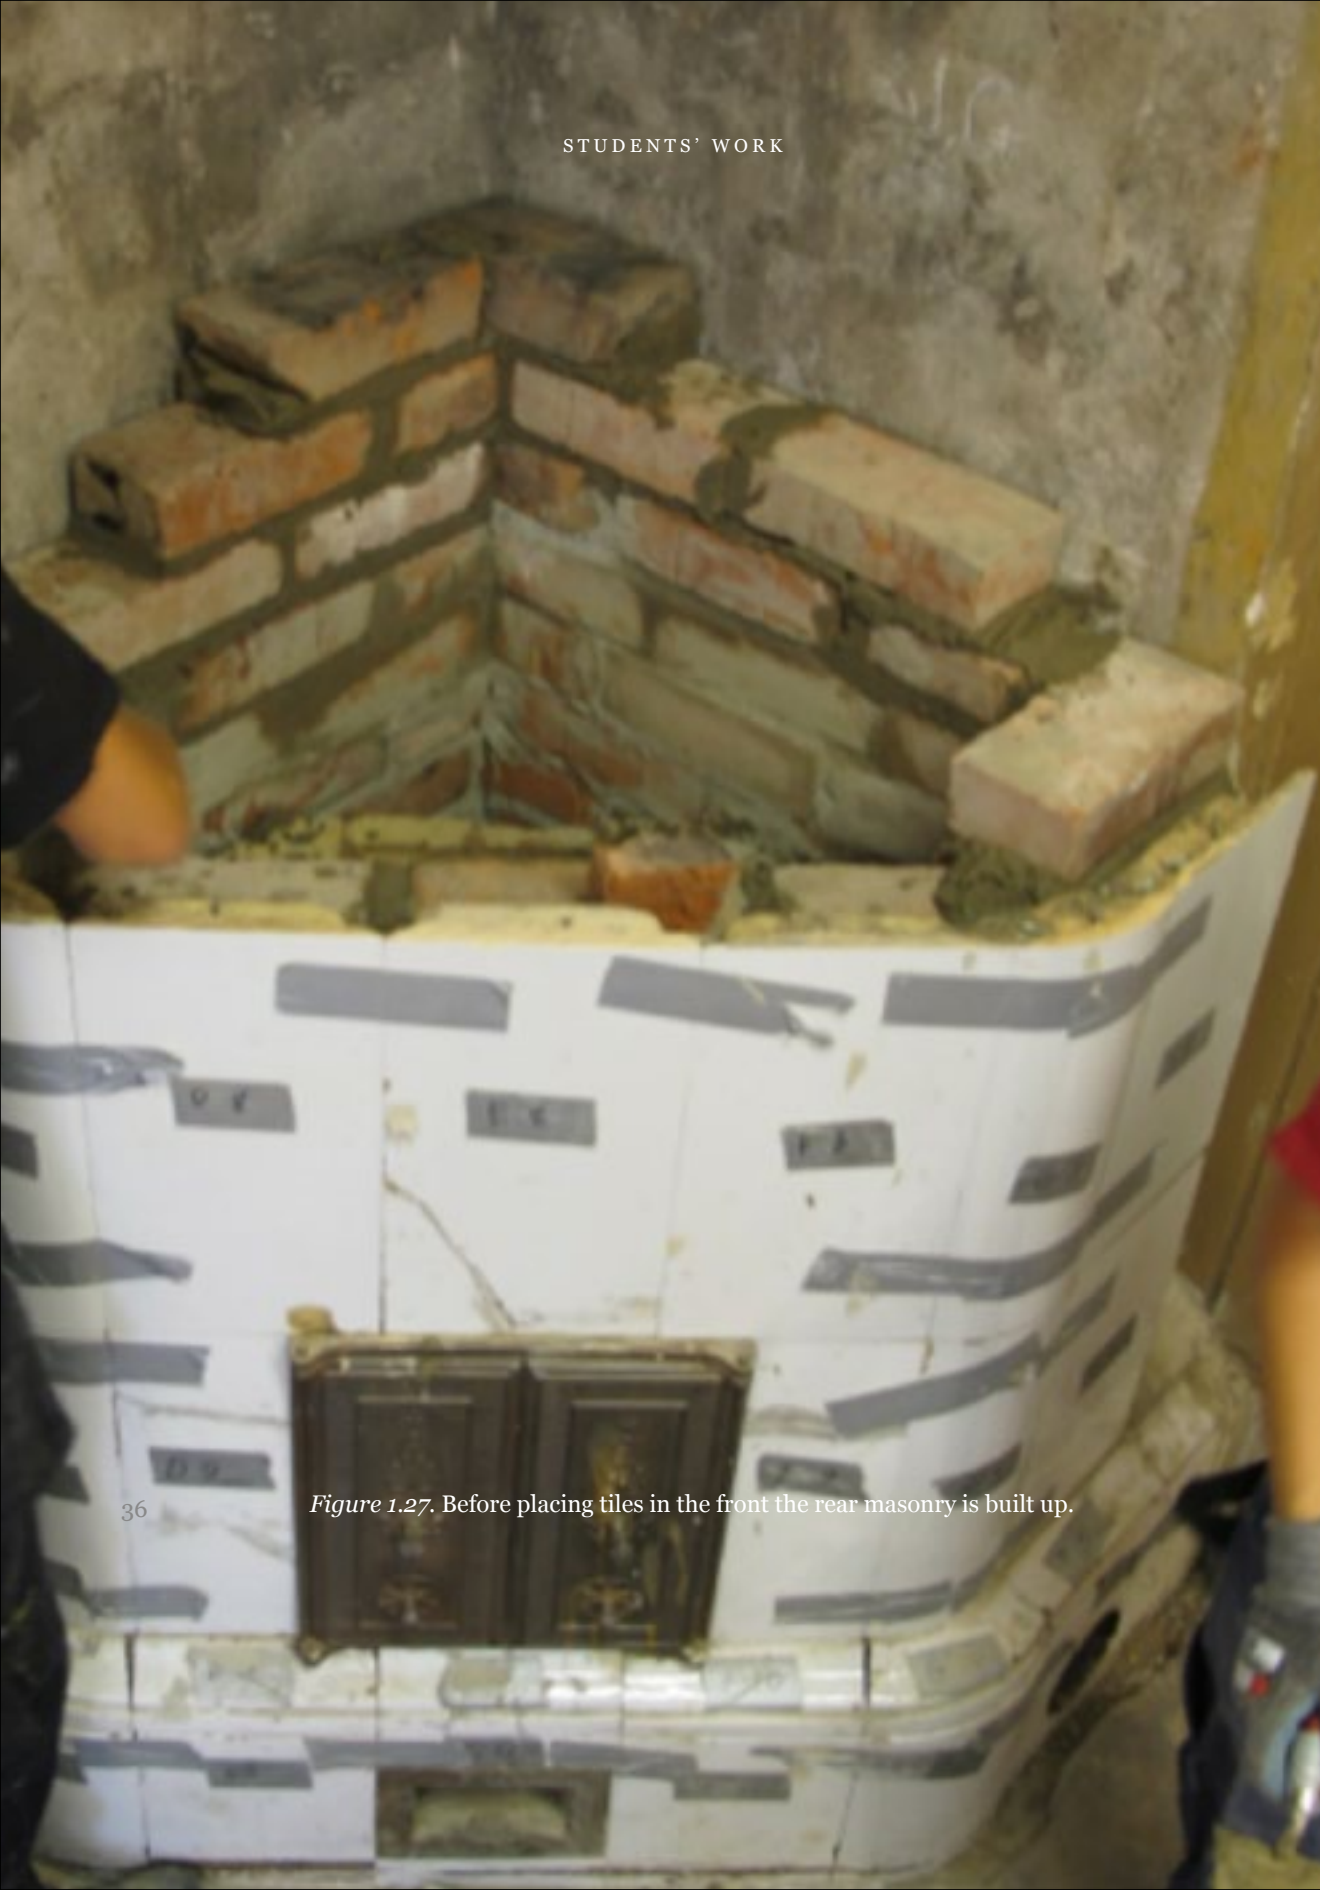
Figure 1.27. Before placing tiles in the front the rear masonry is built up.

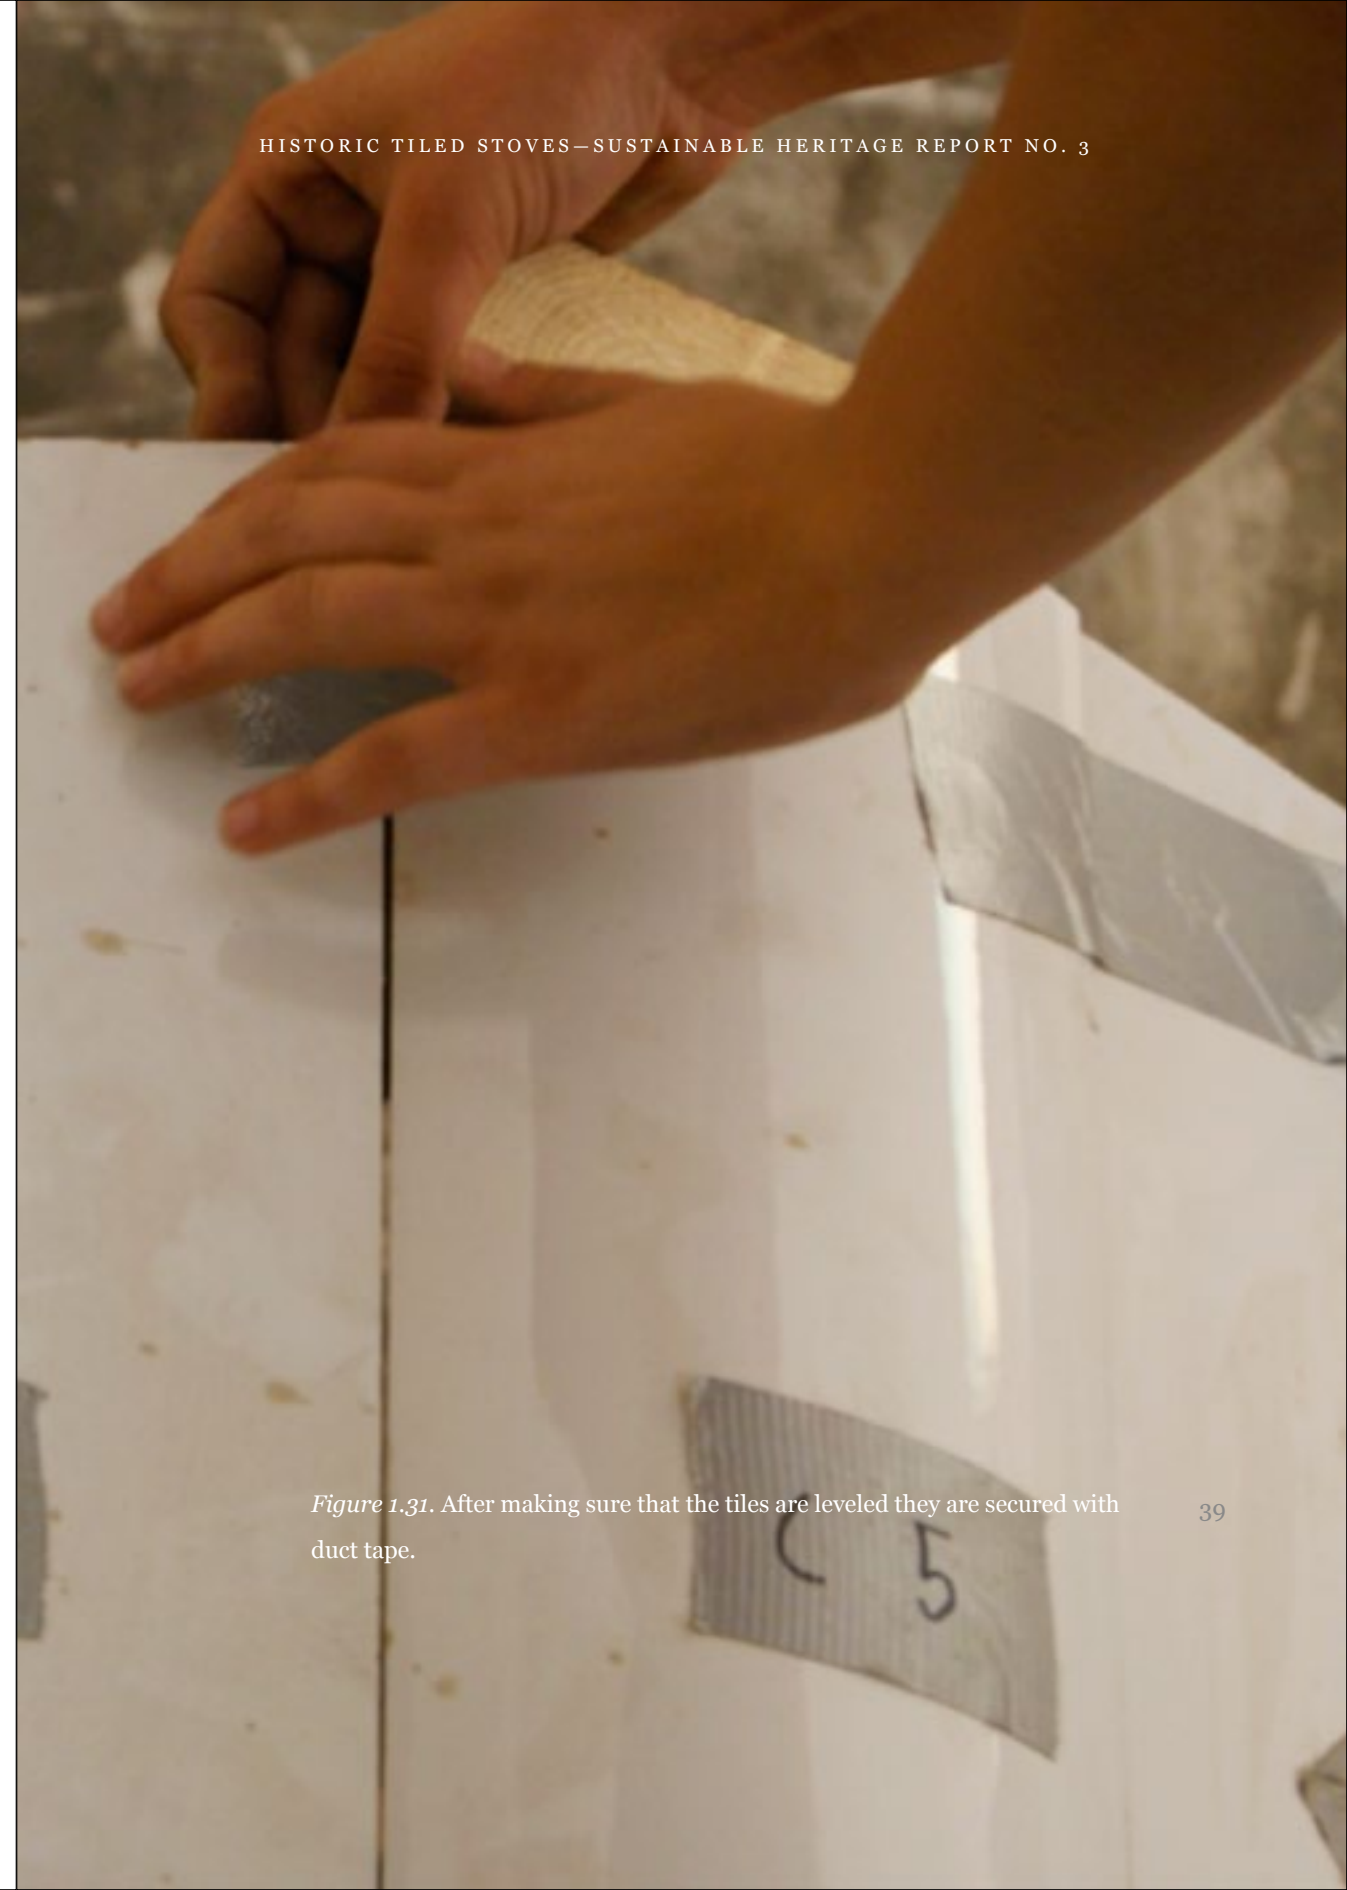
Figure 1.31. After making sure that the tiles are leveled they are secured with duct tape.

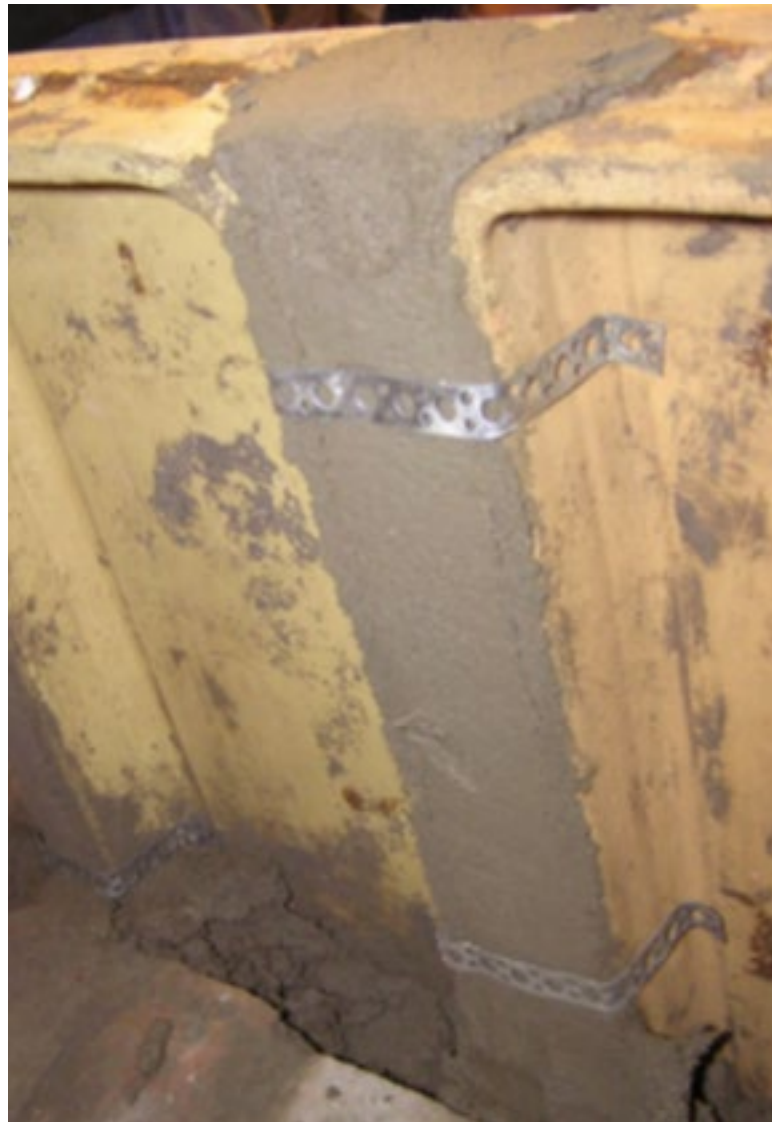
Figure 1.32–33. When the tiles are in place, the gap between them is filled with clay–mortar. Then two clamps made of perforated metal strap are bent to hold them together. The cavity on the backside of the tiles is then filled with mortar and thin bricks. Inside this a wall of bricks is built to finally stabilize the front.

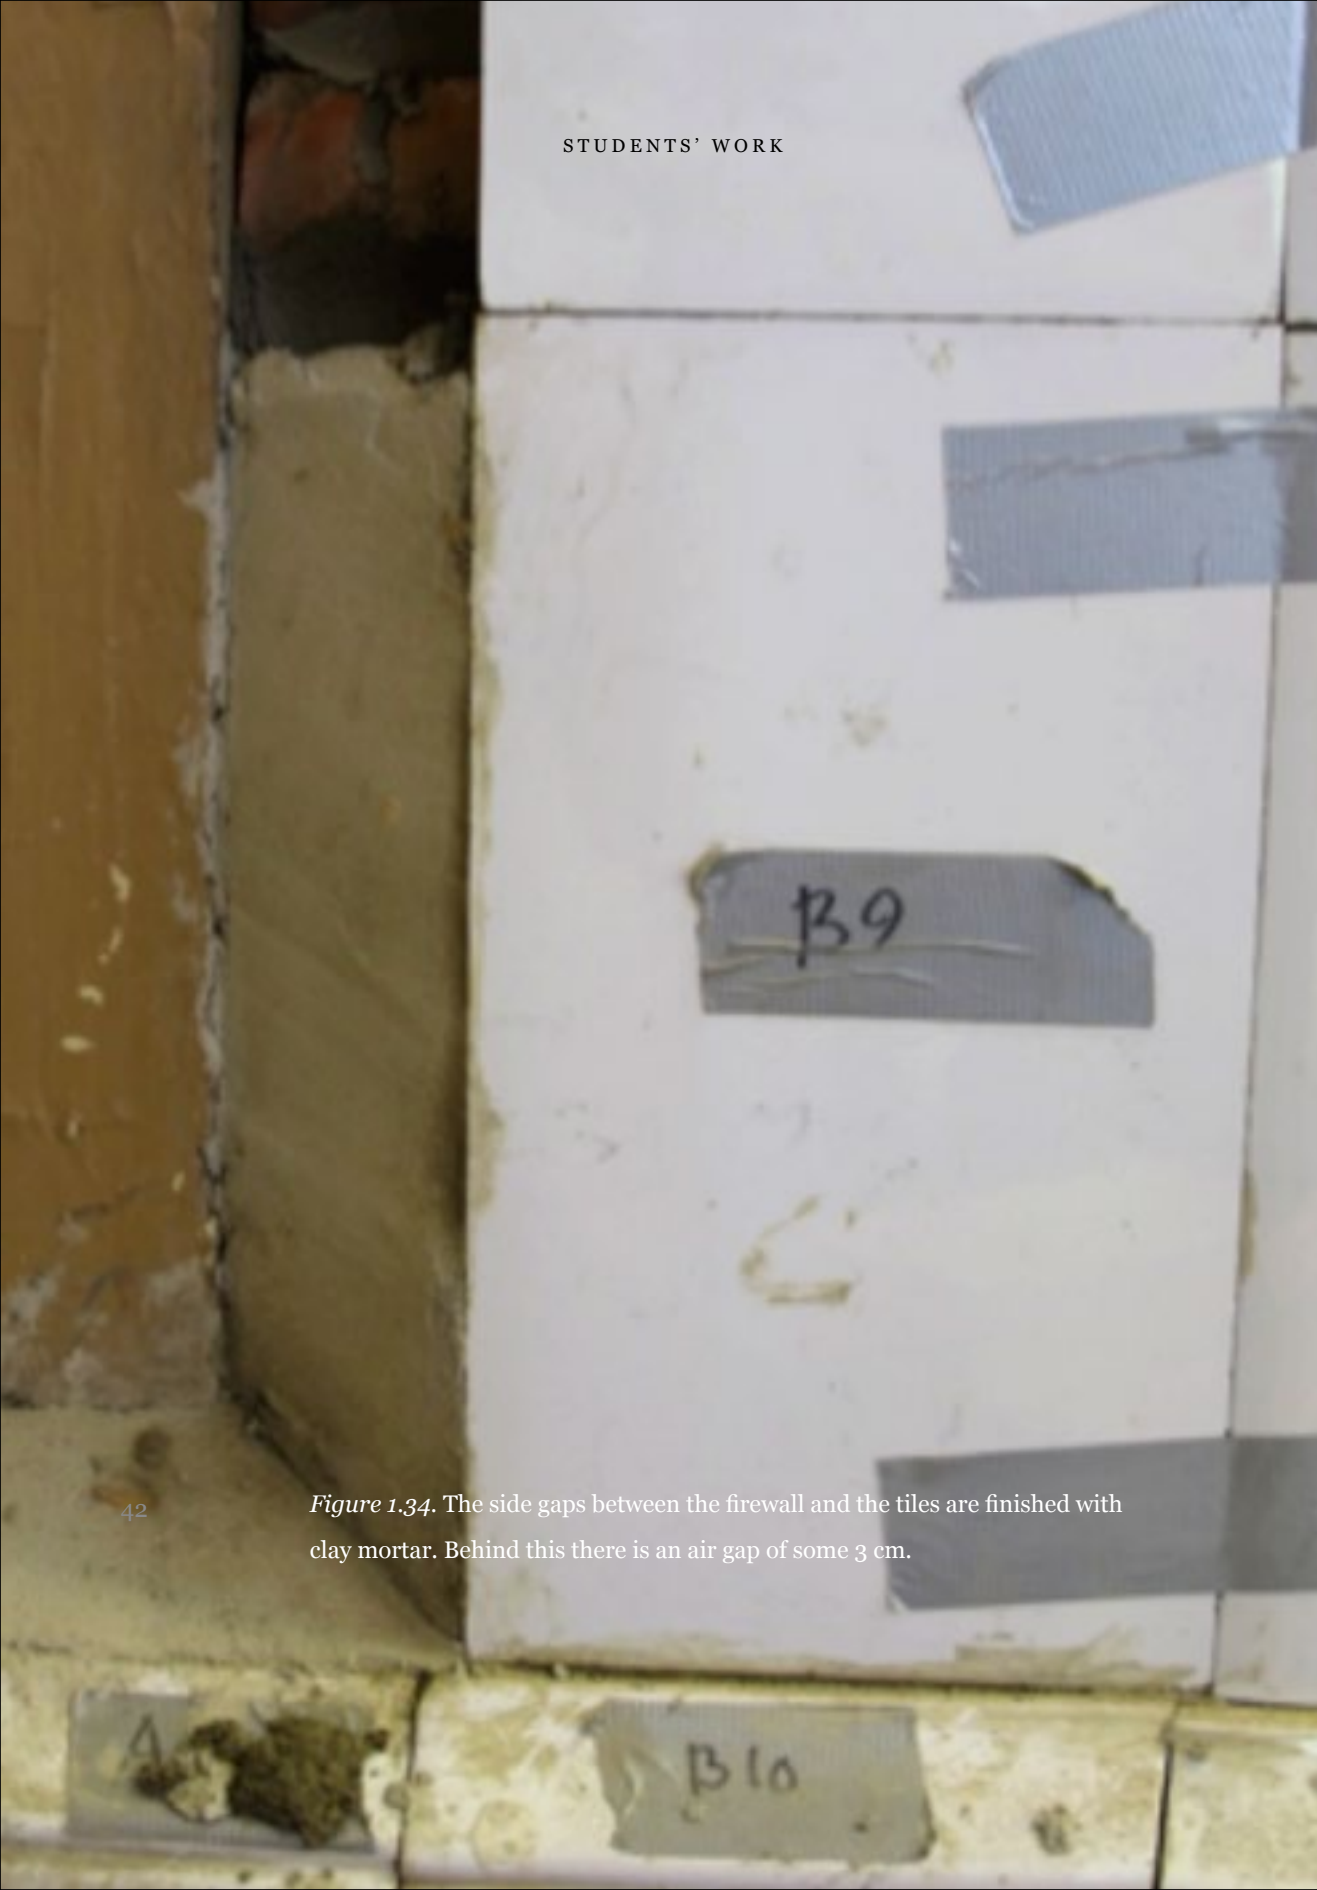
Figure 1.34. The side gaps between the firewall and the tiles are finished with clay mortar. Behind this there is an air gap of some 3 cm.

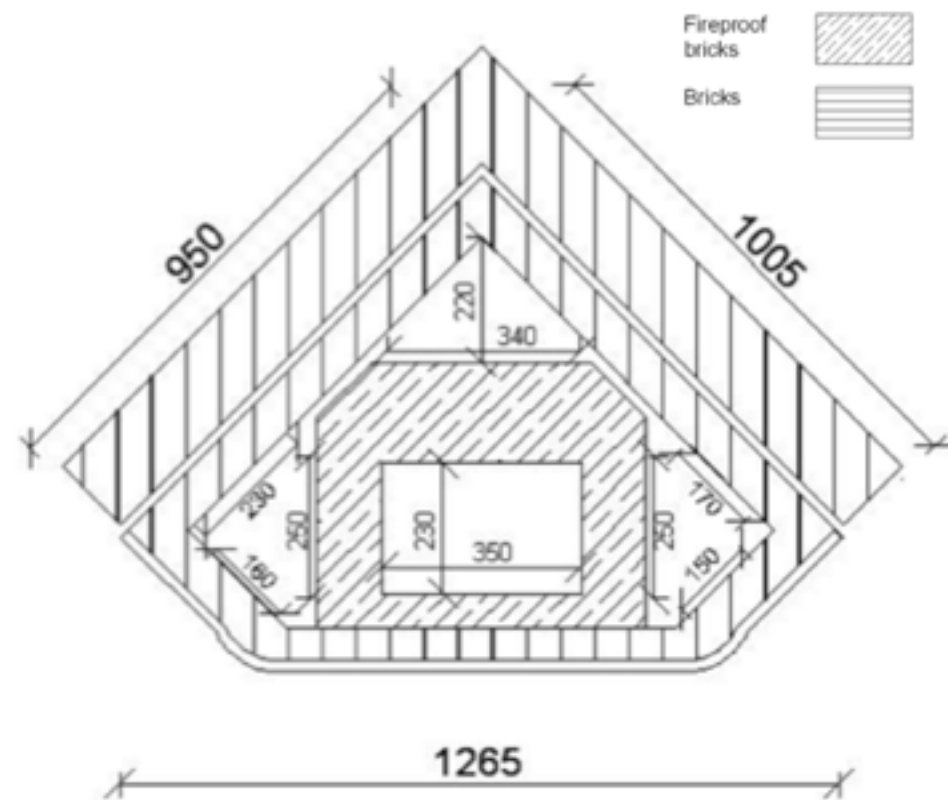
Figure 1.37. Measured drawing: section some 1000 mm above floor level. Regular bricks 265 x 125 x 75 mm; fireproof bricks 225 x 110 x 60 mm; tile and brick, thickness 75 mm.

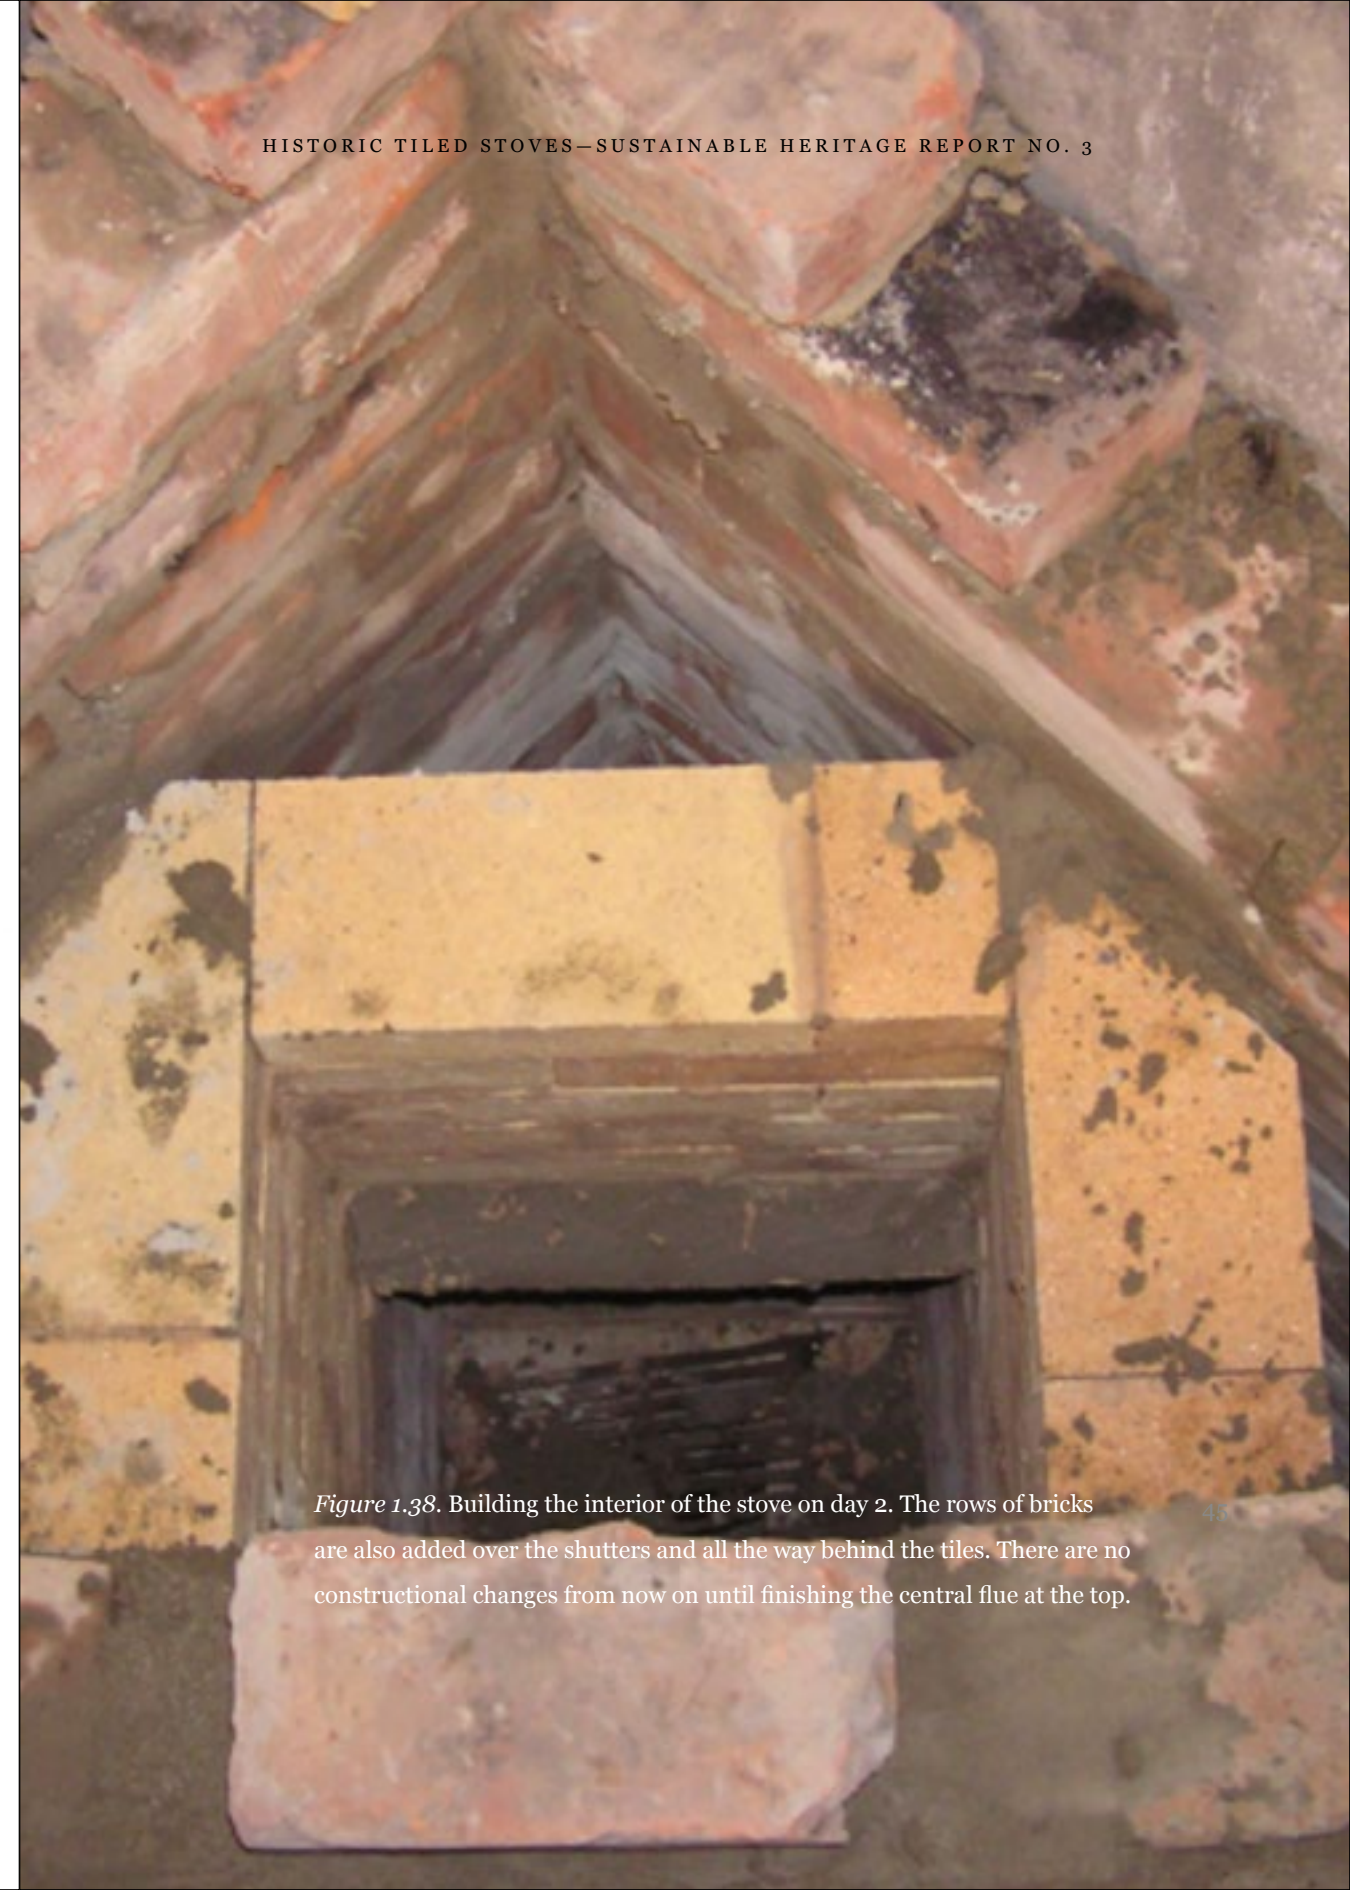
Figure 1.38. Building the interior of the stove on day 2. The rows of bricks are also added over the shutters and all the way behind the tiles. There are no constructional changes from now on until finishing the central flue at the top.

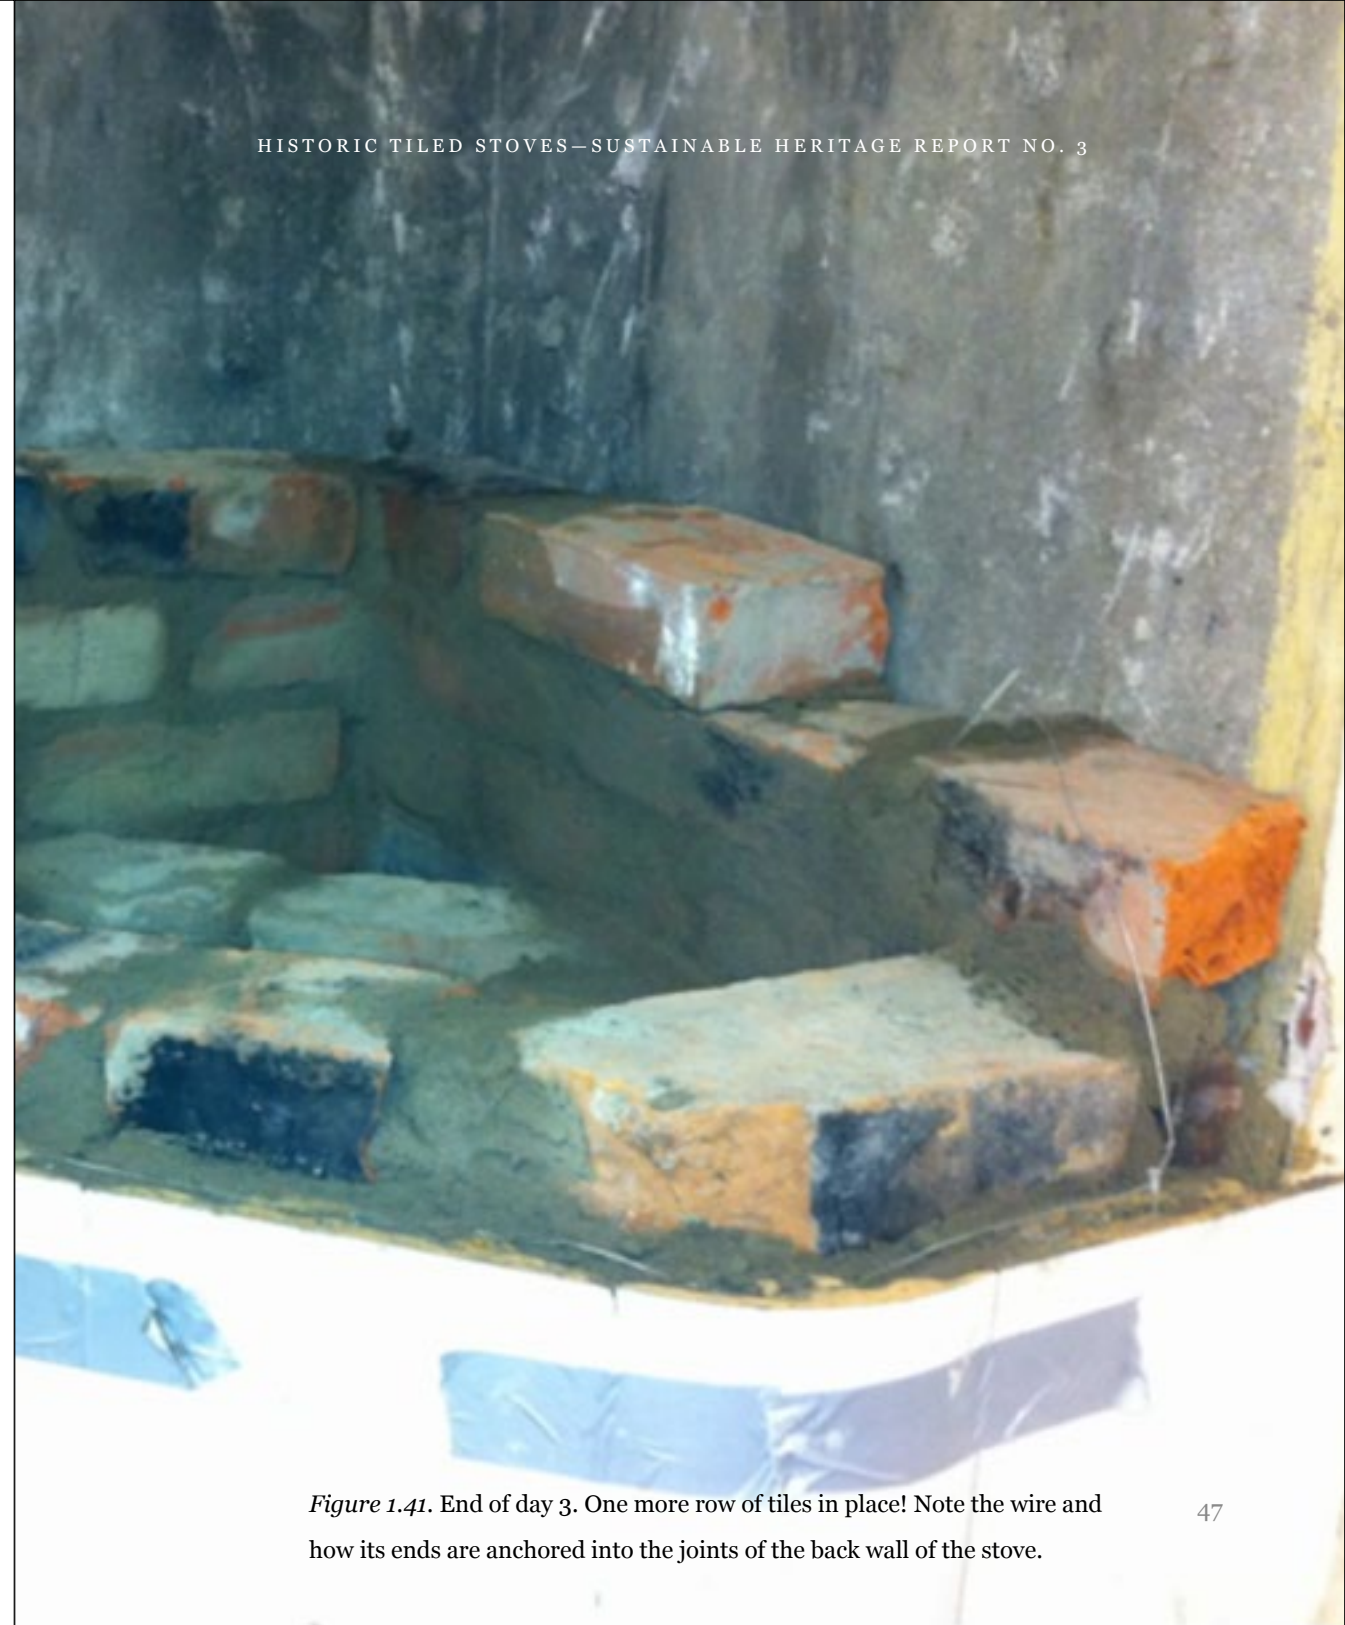
Figure 1.41. End of day 3. One more row of tiles in place! Note the wire and how its ends are anchored into the joints of the back wall of the stove.

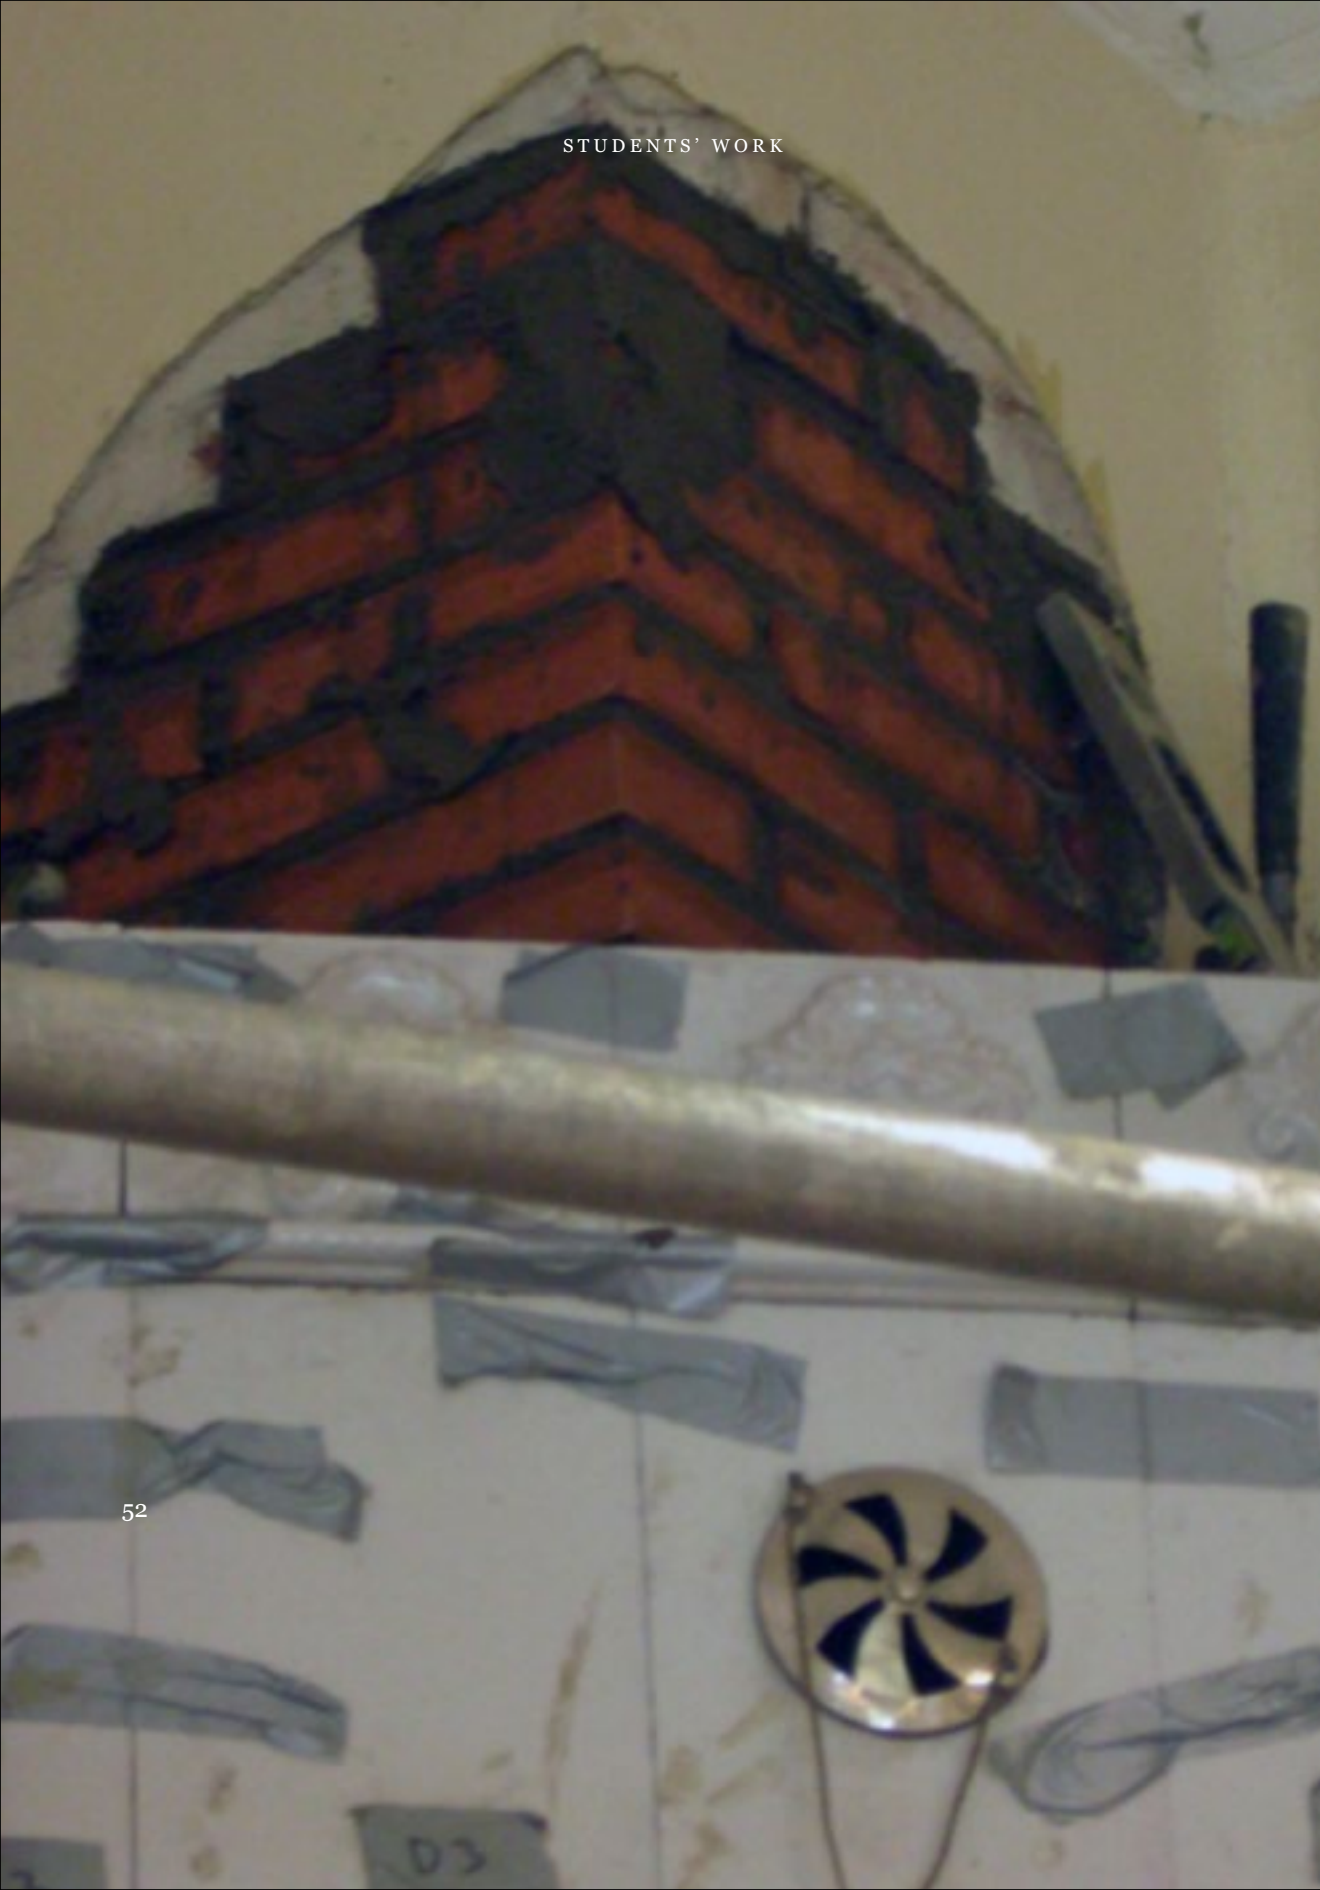
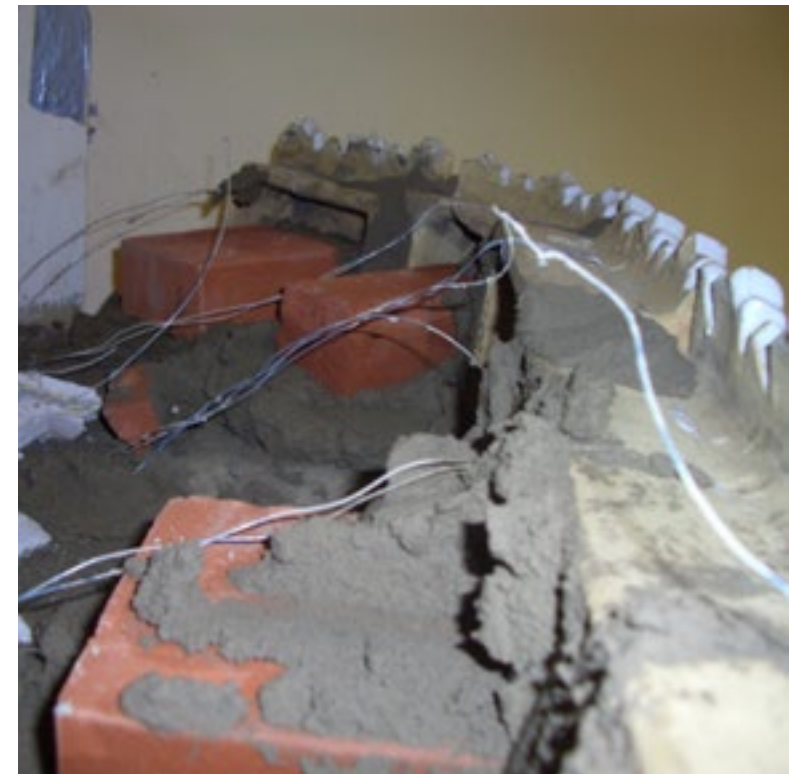
Figures 1.47–48. The chimney was repaired (left), before the crown tiles were finally inserted.

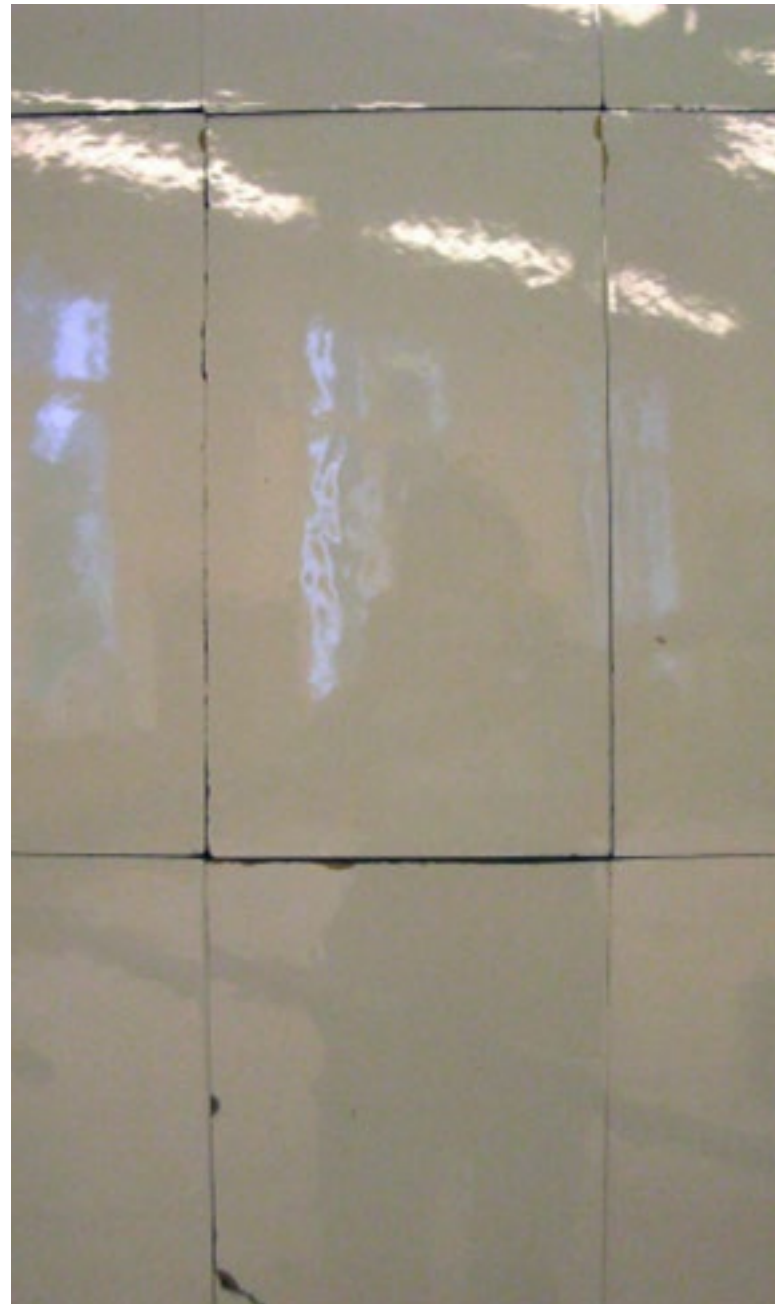
Figure 1.49. The face of the stove before joints and cracks were filled.

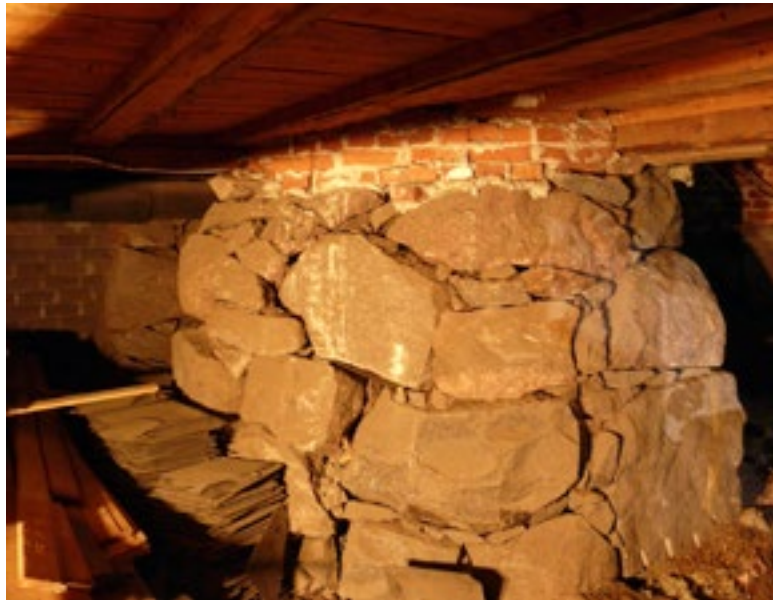
Figure 2.1. Every kind of stove or fireplace has to stand secure and immobile since movements in the masonry would lead to cracks and obvious fire hazard. This enormous dry laid foundation supports the stove whose dismantling and consequent rebuilding is described in the following. The stove itself weighs several tons.

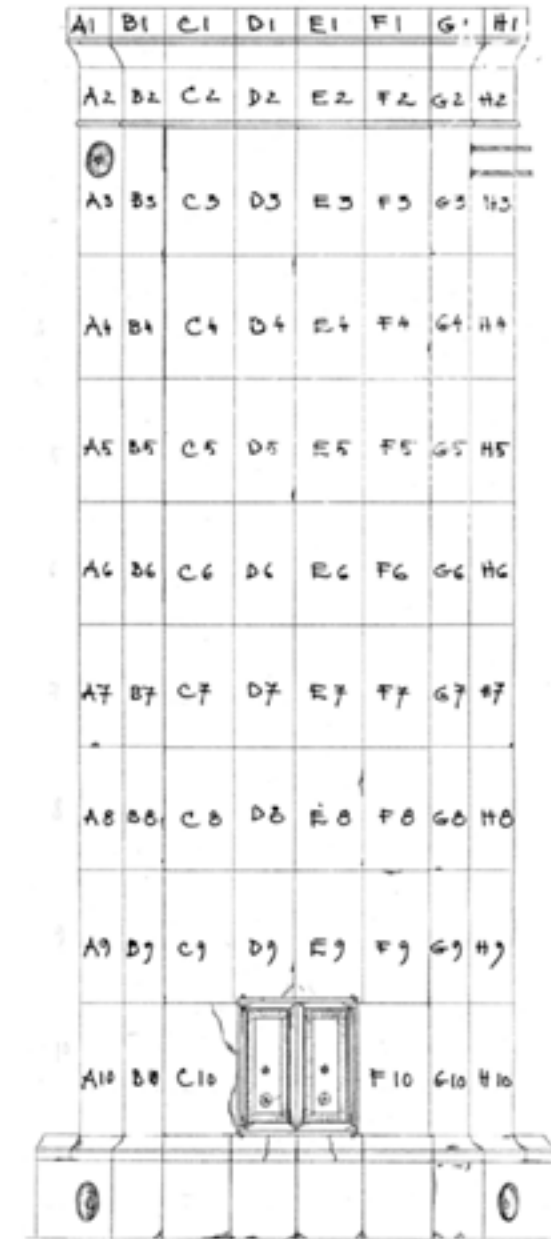
Figure 2.2. Measured drawing of the stove with a symbol for each tile. There are always slight variations in the measurements of tiles and therefore it is important to keep them in the same position when you rebuild the stove.

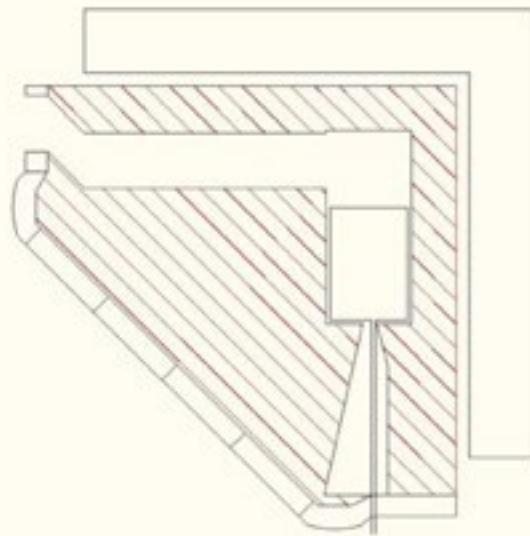
Figures 2.5 a, b. Top air duct was then revealed on the left hand side. Tiled stoves often have an air duct for ventilation in the summer months when the natural air conditioning through the furnace is not in use. This is why there are two dampers: in summer the bottom damper is closed so as to enhance the air flow through the vent into the chimney. When the stove is heated both dampers must be open and when the fire is down the top damper is closed in order to keep the heat from escaping. Also if you want to ventilate after heating you can close the bottom damper and open the top one. The warm chimney will accelerate the flow of air. Ingenious!

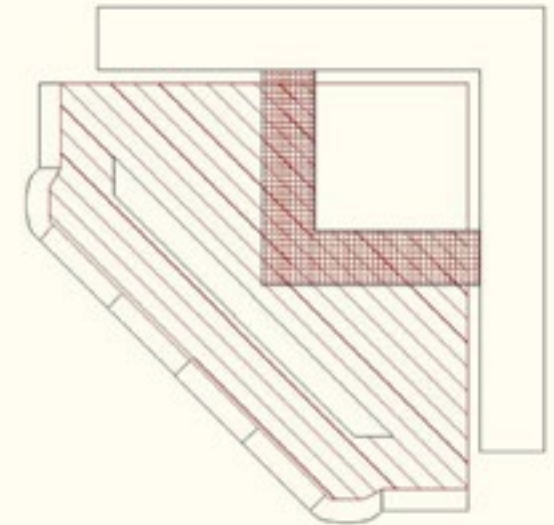
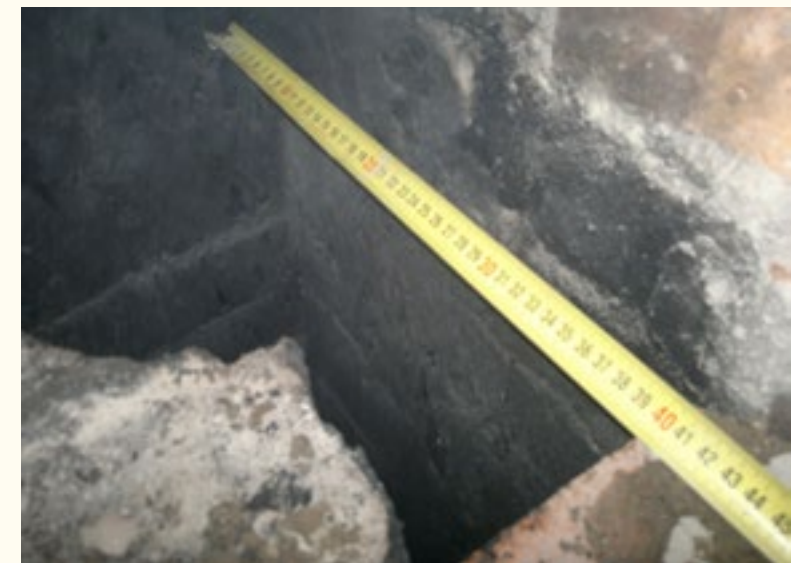
Figures 2.9 a, b. The rear smoke flue which leads to the chimney is found at the top of the fifth tile row. *Above:* drawing of the same.

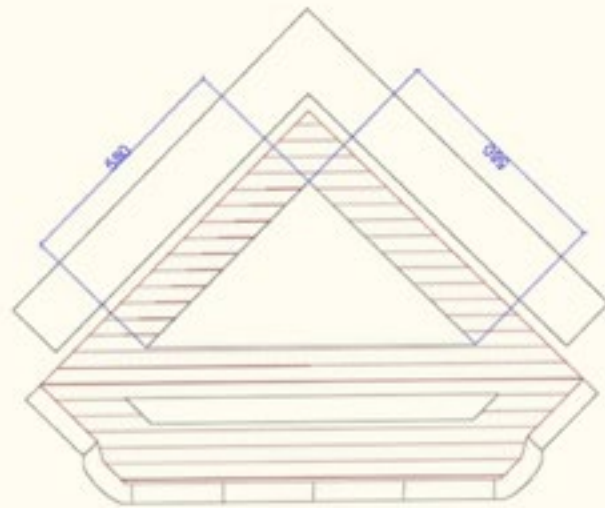
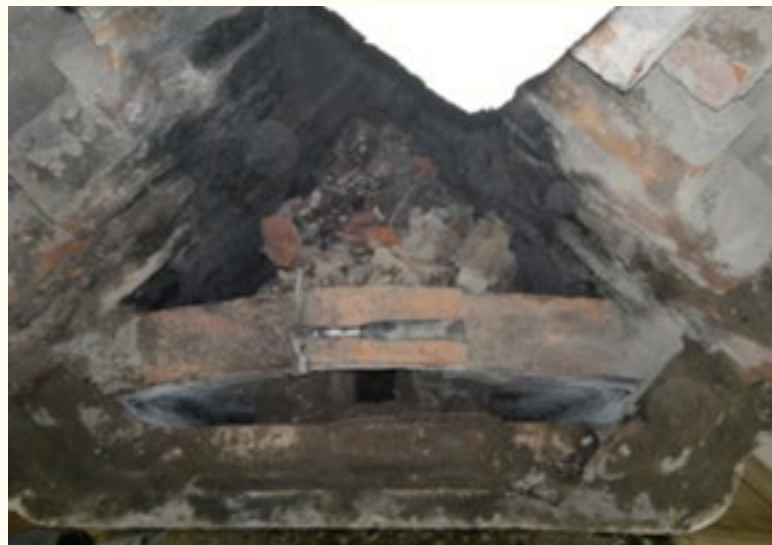
Figures 2.10 a, b. One row of bricks below the top of the fifth tile row: At last we can see the basic structure of the stove with its 5 flues. *Above:* measured drawing of the same.

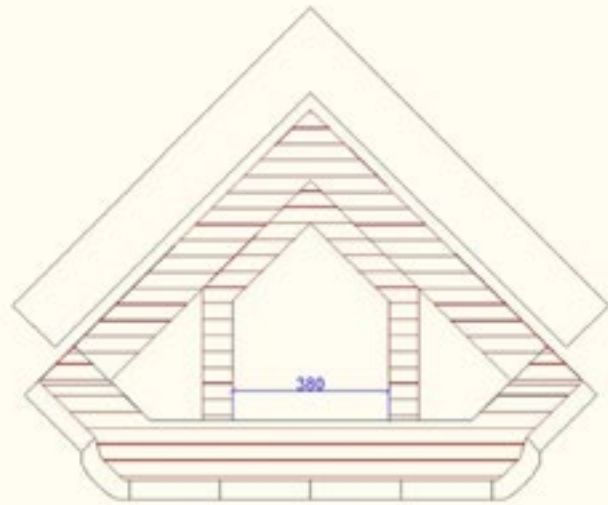
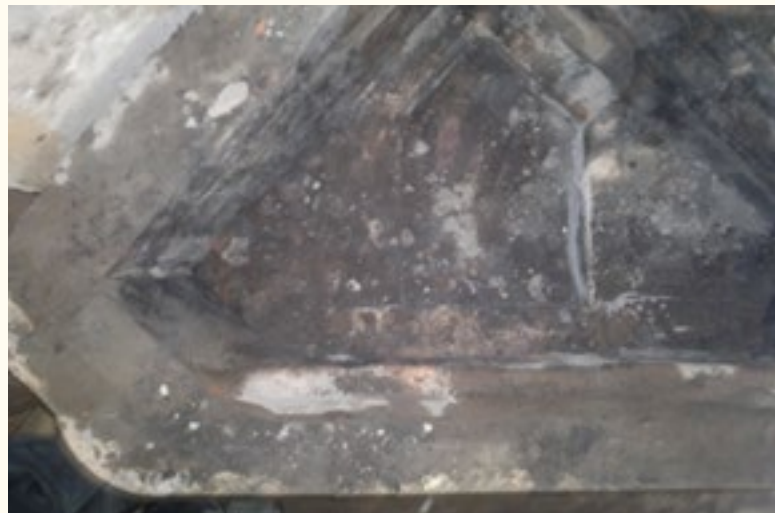
Figures 2.14 a, b. The ninth tile row is still in place but several rows of brick have been taken out from behind it. Here the floor of the furnace can be seen. This is where the dismantling was stopped because the bottom of the stove was intact and it was of course easier to start the rebuilding from a foundation that was of the correct size and shape. *Above:* measured drawing of the same.
